# Preliminary Assessment Sampling and Analysis Plan

## Crawford Street Site Portland, Oregon

*Prepared for*  
Crawford Street Corporation

August 11, 2000

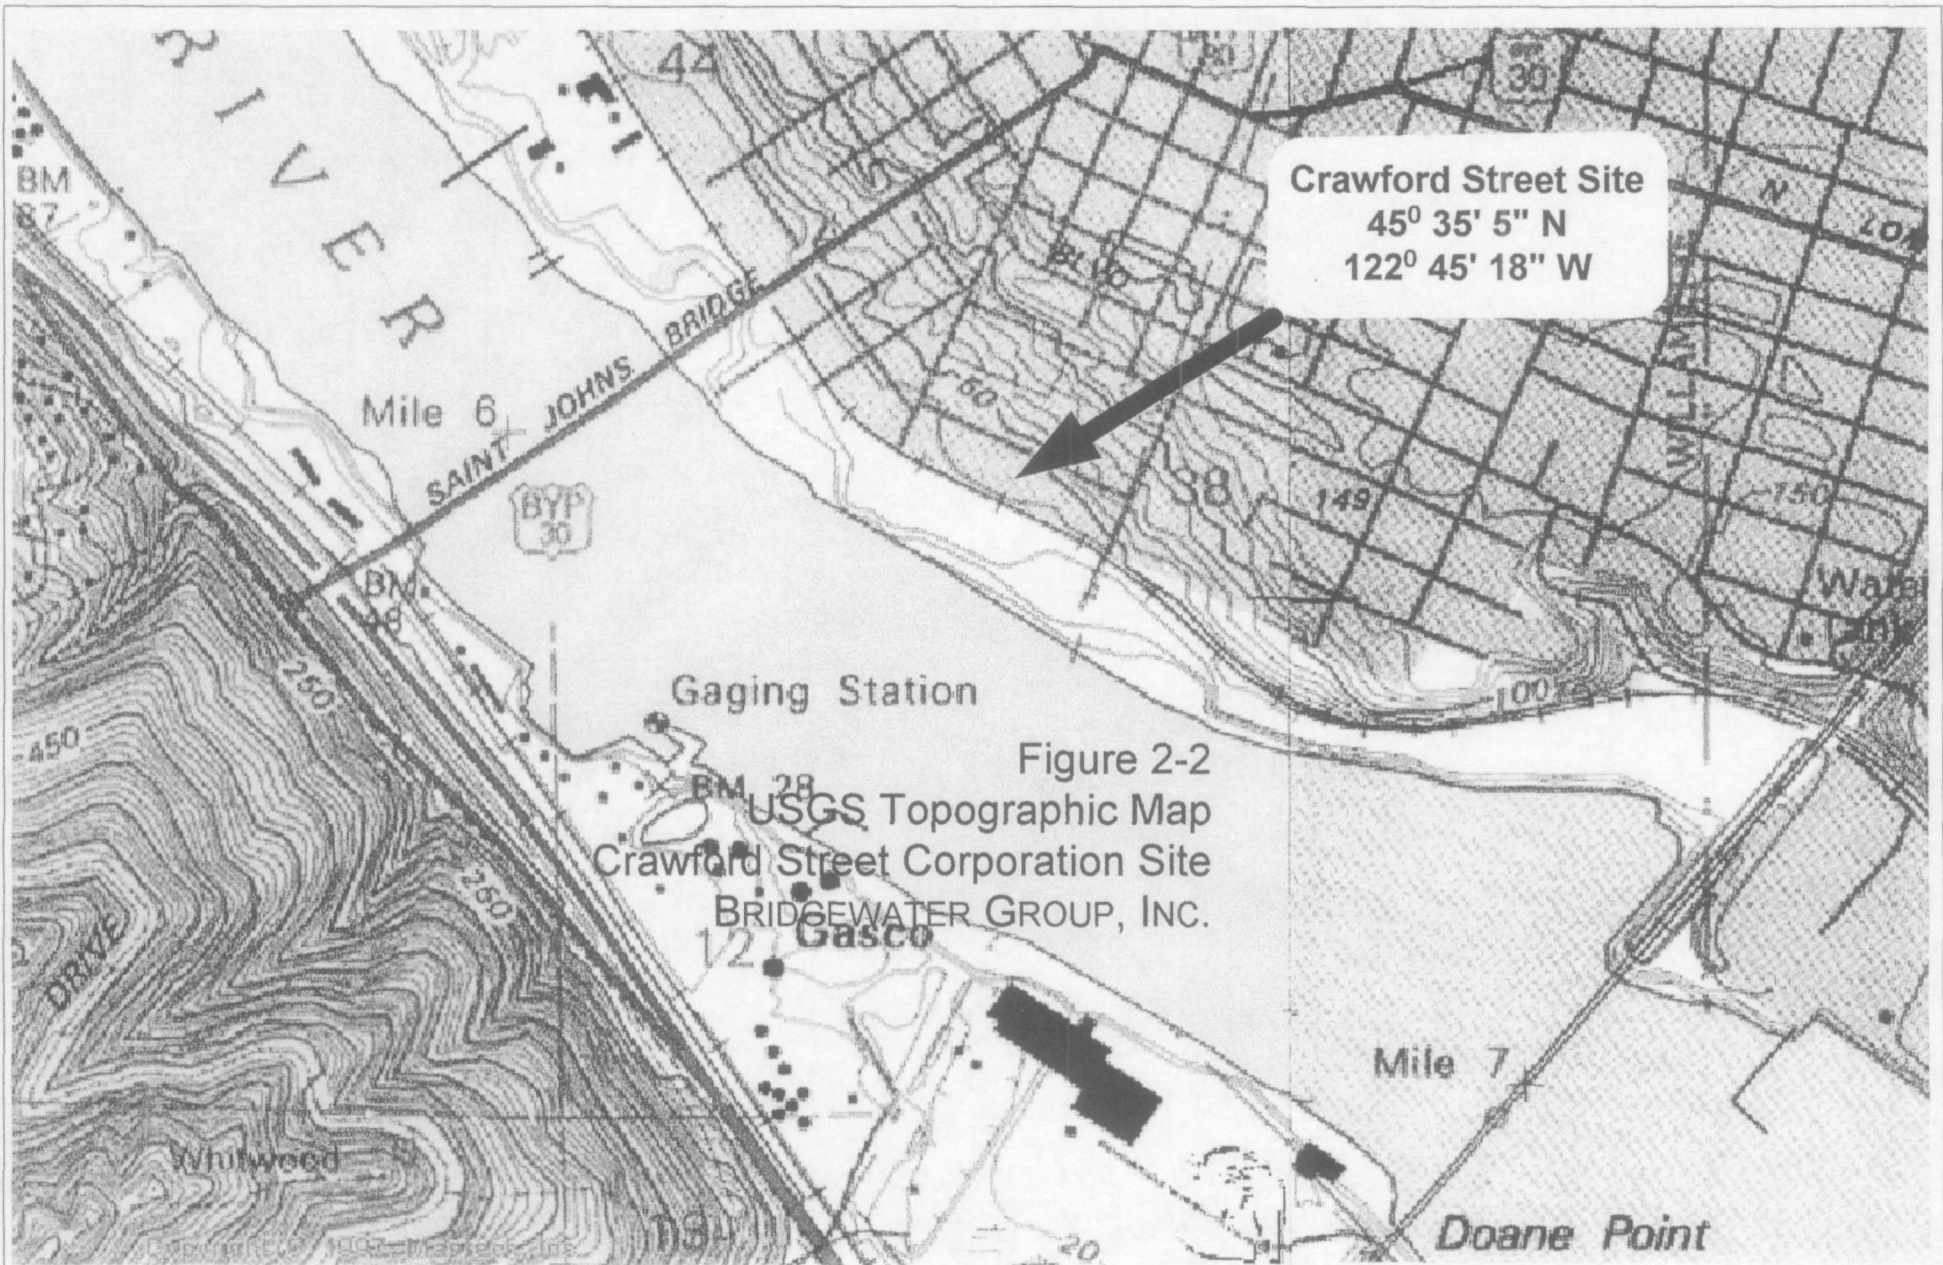
**Figure 2-2**  
USGS Topographic Map  
Crawford Street Corporation Site  
BRIDGEWATER GROUP, INC.

Figure from USGS  
Topographic Map Linnton  
and Portland Quadrangles  
Photorevised 1990

Approximate Scale  
833 feet

The overall site area slopes down, relatively steeply north of the CSC site, from north to south with a slight slope down from east to west. A USGS Map showing the regional topography is presented in Figure 2-2. A 1998 aerial photograph is presented in Figure 2-3. Appendix A presents representative photographs of the current site conditions.

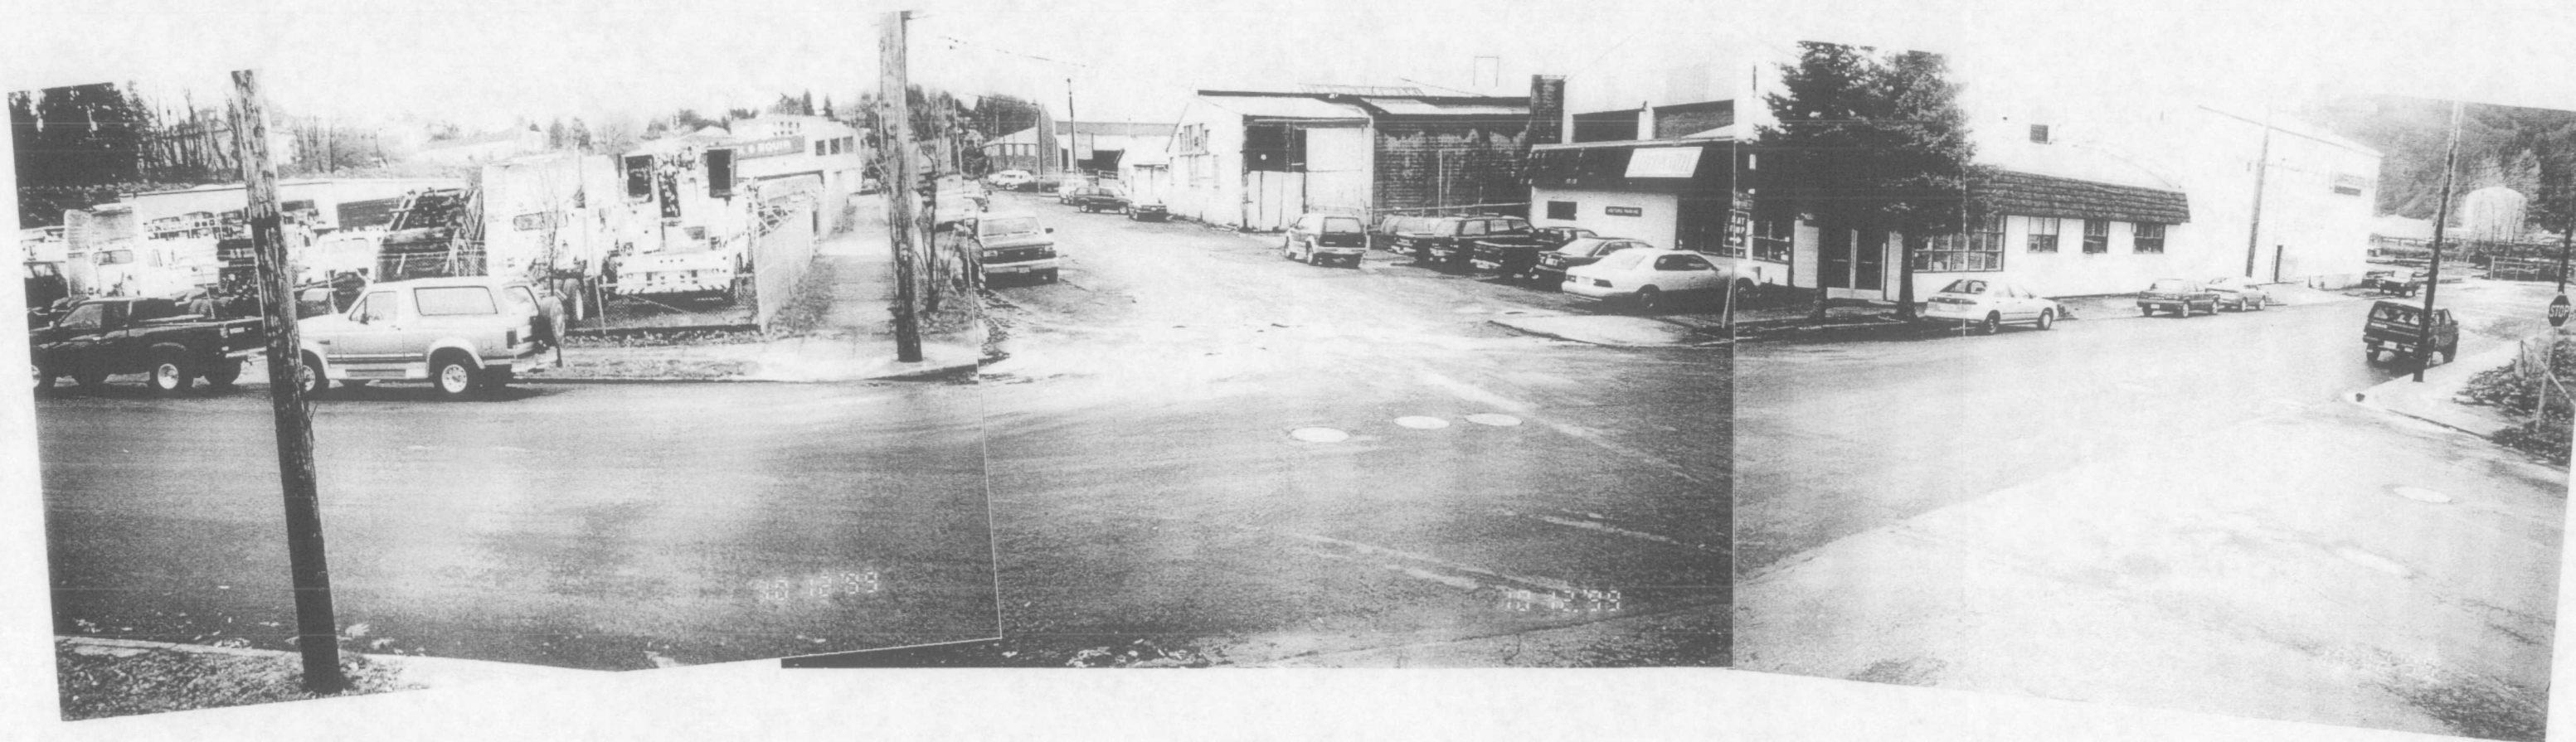
Photo No. 1

Looking southeast from intersection of North Burlington and North Crawford Streets.

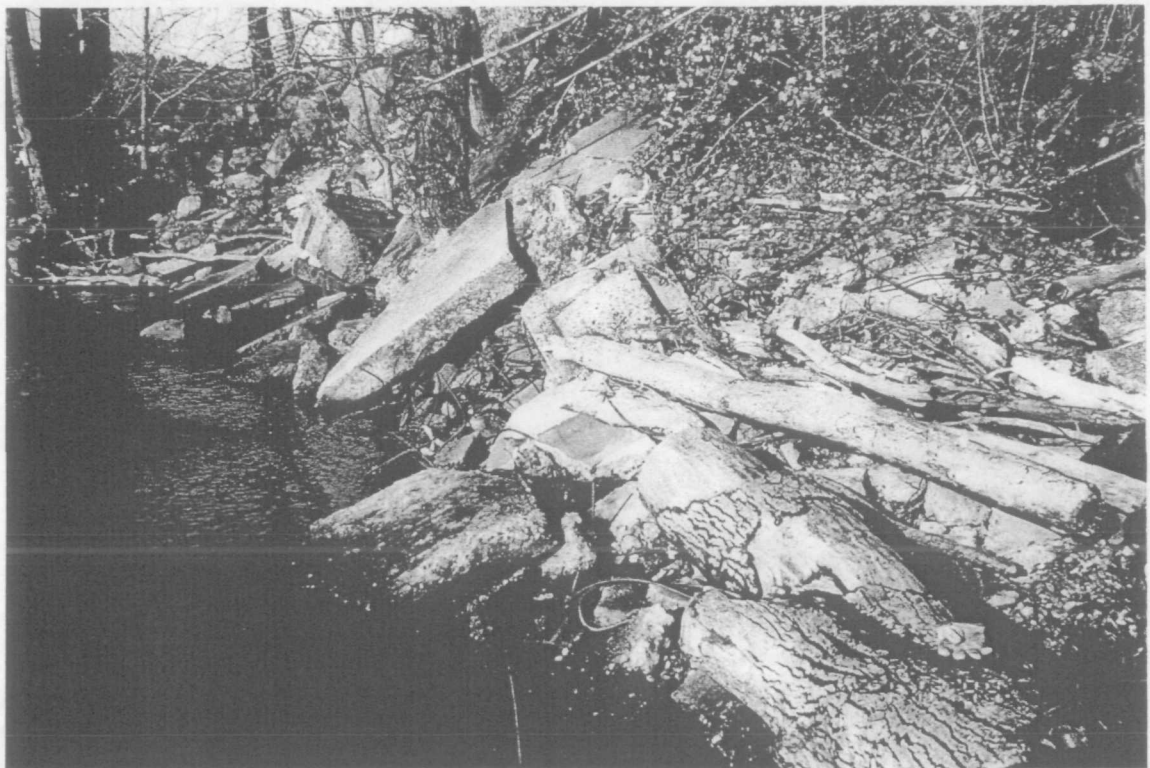
Photo No: 17

Typical river bank conditions.

The riverbank is vegetated with blackberries and small trees. Most of the bank is covered with concrete debris and logs. Some of the concrete debris is larger than 6 feet with logs greater than 20 feet long. Smaller asphalt debris was also observed on the riverbank. Although the vegetation limited the ability to closely observe, no seeps were observed along the riverbank during the site reconnaissance. A nominal 8-inch diameter concrete pipe was observed protruding from the river bank about 200 feet east of the western boundary of the site. No evidence of recent flow from the pipe was observed (even after recent wet weather) and the pipe appeared to be associated with previous uses of the site.

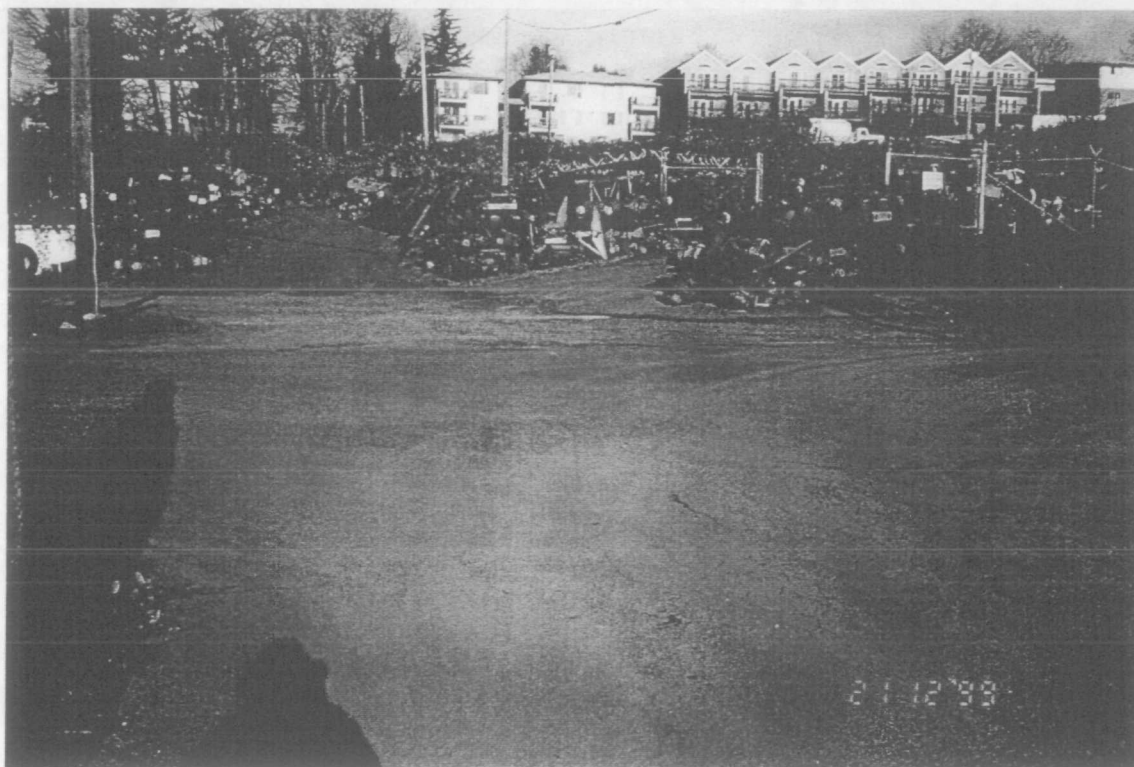
**Photo No. 18**

Looking north from north side of Columbia Forge/Lampros Steel yard at St. Johns Truck and Equipment debris yard. Storm water runs from this area, across Crawford Street, and on to and across the storage yard.

Storm water runoff from these up gradient areas flows on to, and across the CSC site. In particular, runoff flows off of the St. Johns Truck and Equipment site and flows on to the Lampros Steel property at the west end of the CSC site, onto the Columbia Forge yard, and onto the Columbia Forge and Lampros Steel yard at North John Street. A sheen was observed on this runoff during the site visit. CSC constructed an asphalt berm along the southern edge of North Crawford Street to reduce the amount of runoff coming on to the CSC site from up gradient properties.

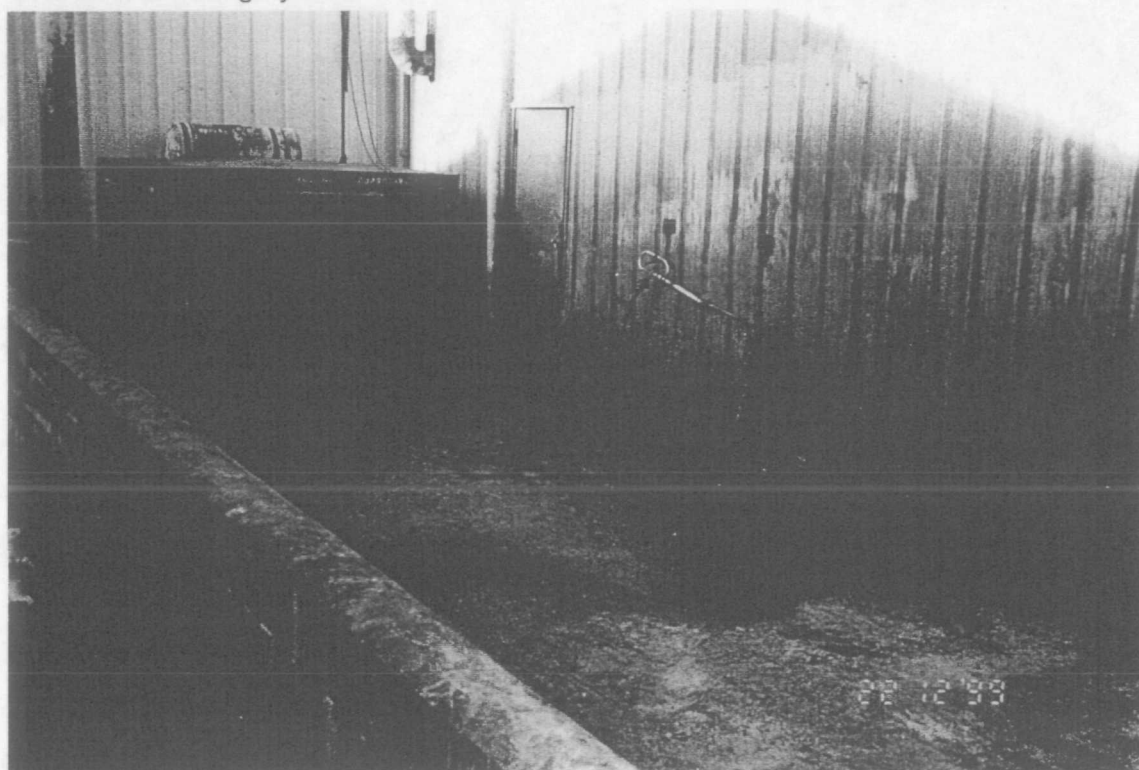
**Photo No: 19**

Stained wash area adjacent to Crawford Street at St. Johns Truck and Equipment. Across Crawford Street from Columbia Forge.

A heavily-stained, uncovered wash pit is present immediately adjacent to North Crawford Street, across the street from the Columbia Forge office. The approximate 15-foot by 30-foot area drains to a sump that presumably drains to the local storm water or sanitary sewer system. The concrete floor in the wash pit was heavily stained with petroleum

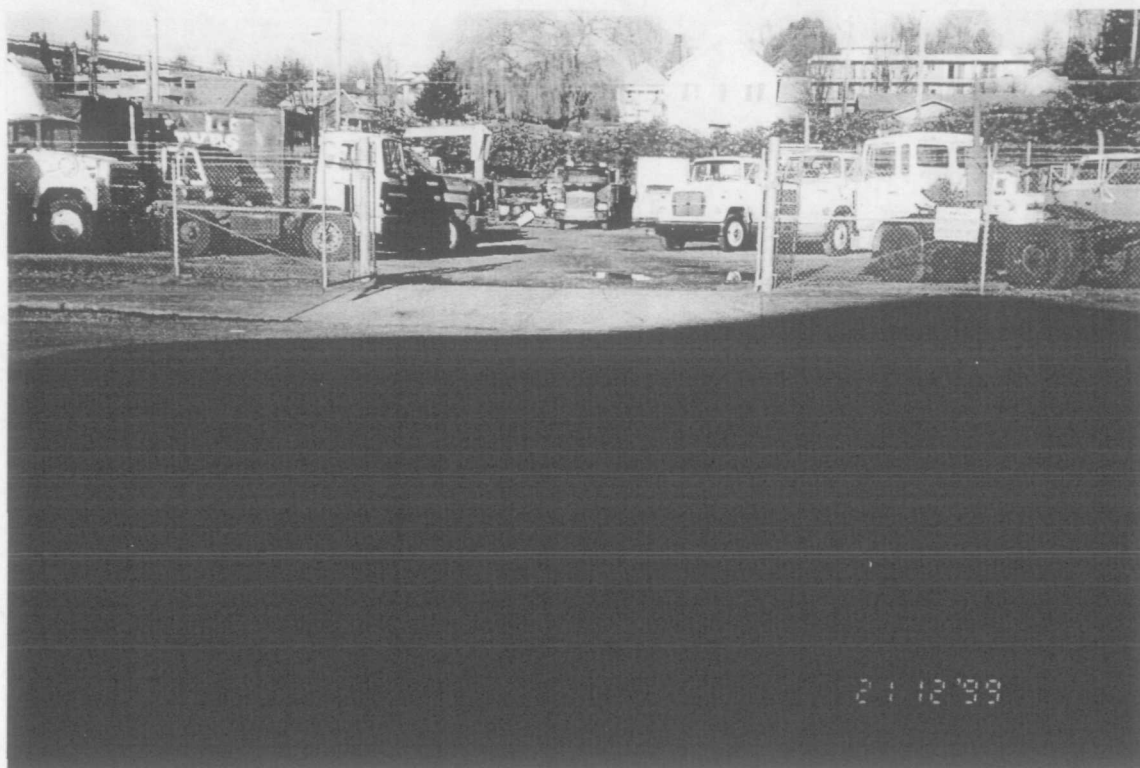
Photo No. 20

Looking north at St. Johns Truck and Equipment truck storage yard. Storm water runs from this area, across Crawford Street, and on to and across the Lampros and TLS Steel areas.

The western portion of this up gradient property (across from Lampros Steel offices) is also used to store trucks. Oil stains are present on the unpaved ground where the trucks are stored. Torch cutting of disassembled truck parts is also being performed in this area.

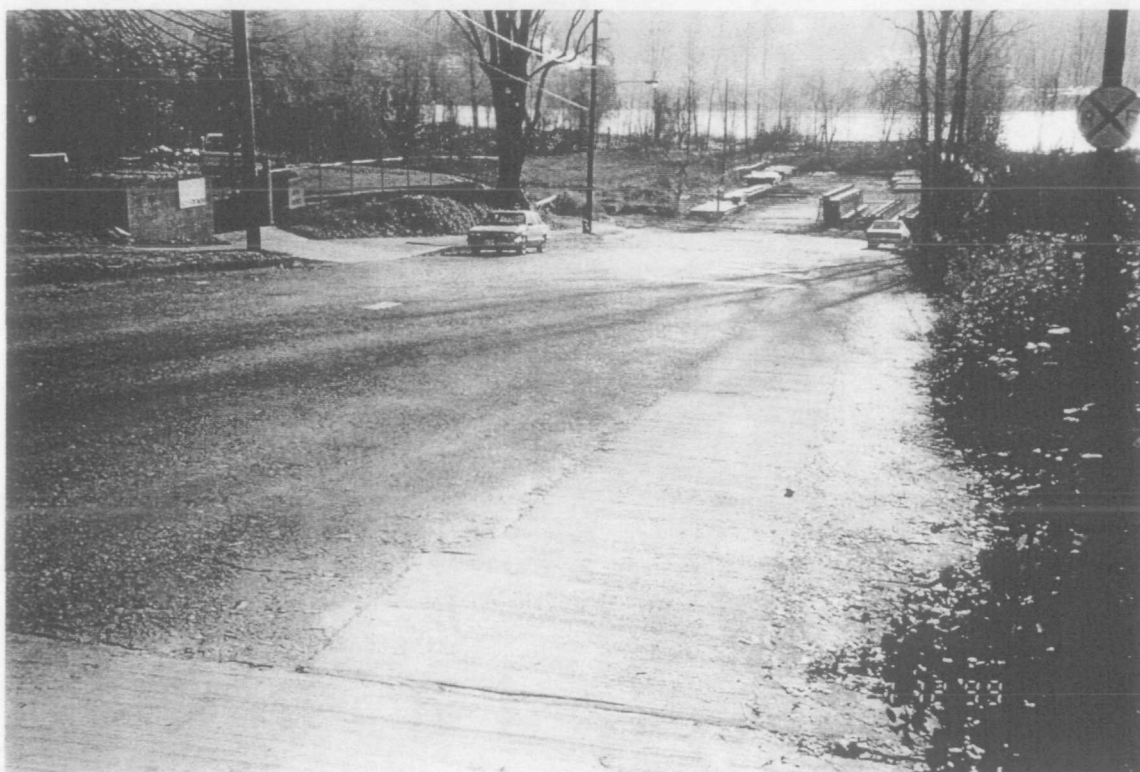
Photo No: 21

Looking south down North Richmond Street. Storm water flows down this street to UPRR rail spur area and to the Lampros Steel south storage yard.

The runoff from the up gradient properties continues across the CSC property to the UPRR rail spur where it ponds and infiltrates. During heavy rainfall events, this runoff from the up gradient properties can flow to the west to the City of Portland catch basin at the intersection of North Burlington Street and the UPRR rail spur.

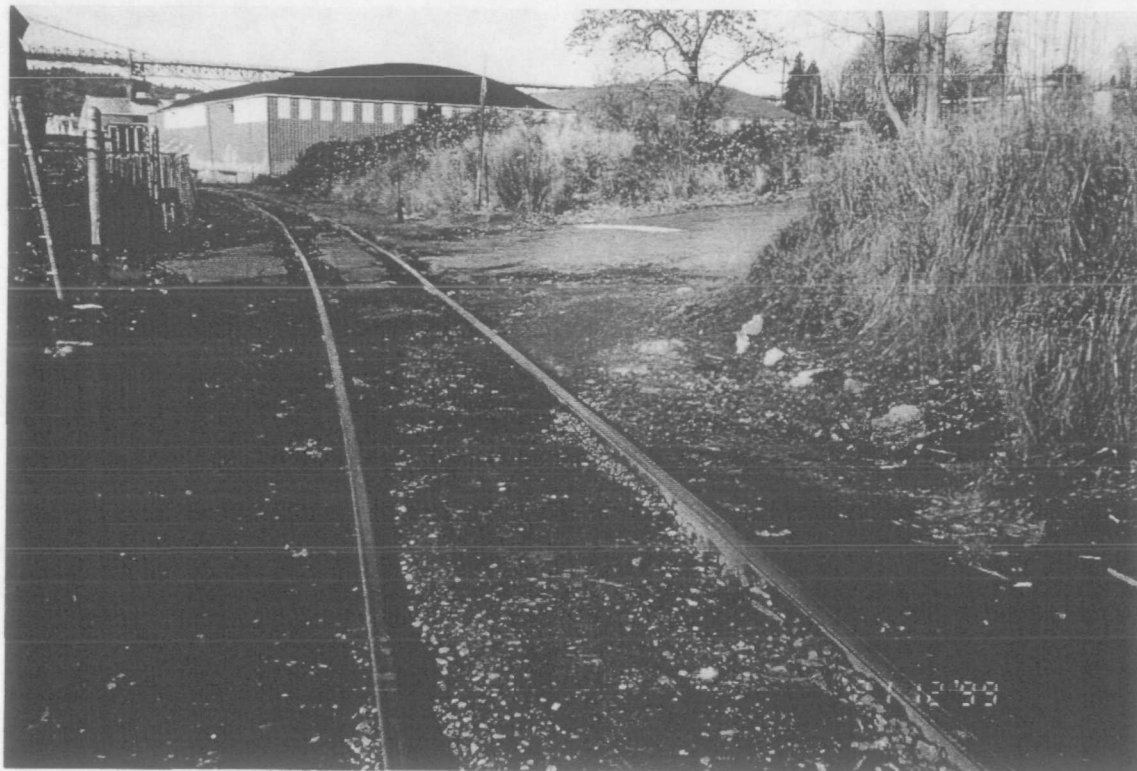
Photo No. 22

Looking west from east of site along UPRR rail spur. Note fresh oil stain in rail alignment east of Crawford Street. Stain drips continue onto the Crawford Street site.

Soil staining typical of rail road operations was observed along the UPRR rail spur separating the North and South Areas. The staining was consistent with petroleum hydrocarbons releases from diesel locomotives and spillage of products from the rail road cars.

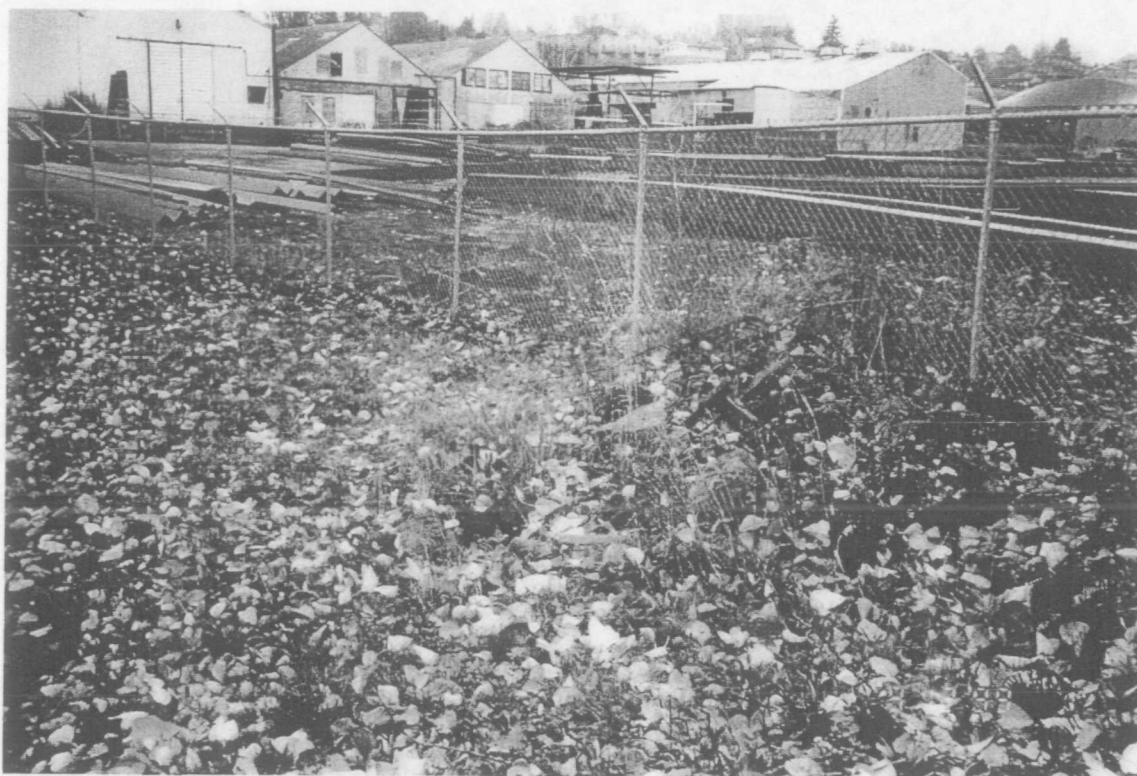
Photo No: 23

Looking northeast from City of Portland property west of Crawford Street site. Note asphalt and concrete debris pile on City property.

The property west (downriver) of the Southern Area of the CSC site is the location of the City of Portland Bureau of Environmental Services (BES) laboratory. This area is mostly paved with some landscaped areas. Storm water runoff in the eastern portion of this area is directed to a small ditch and wetland area in the eastern area of the BES property. A waste pile containing asphalt debris was observed on the eastern edge of the BES property, adjacent to the CSC property. The Willamette riverbank also contains concrete and asphalt debris at the eastern edge of the BES property.

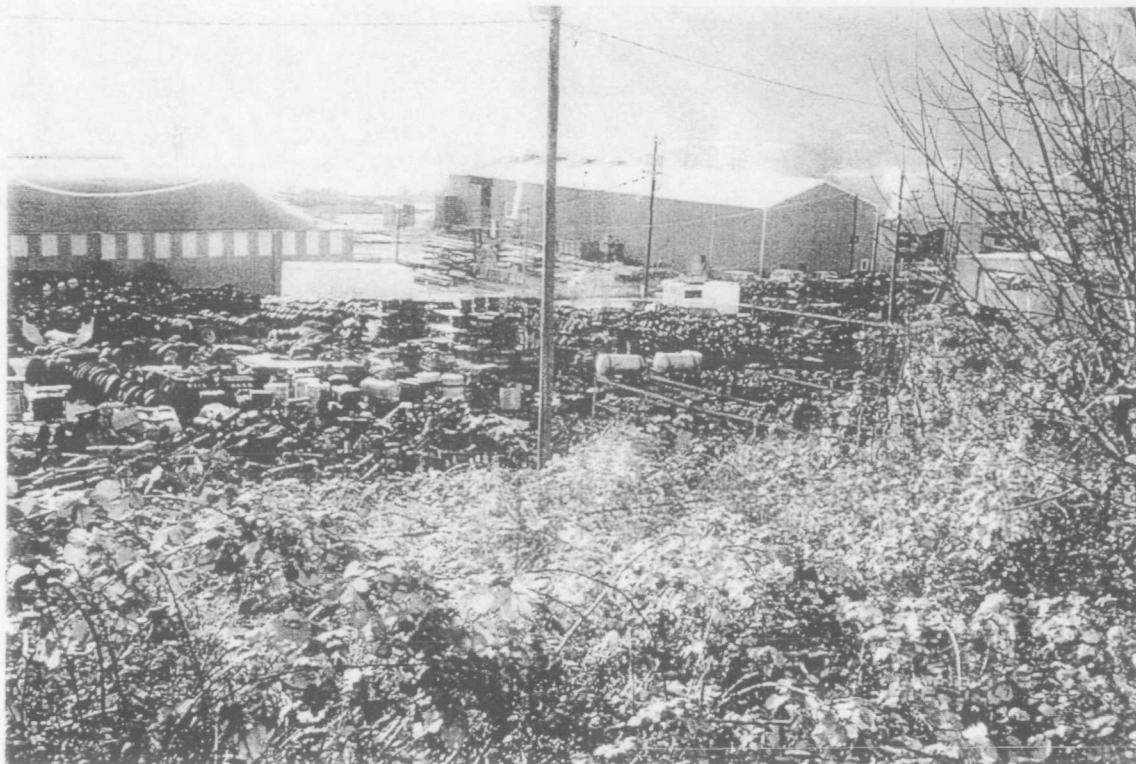
**Photo No. 24**

Looking south from hill above site. St. Johns Truck and Equipment debris yard north (up gradient) of Crawford Street site.

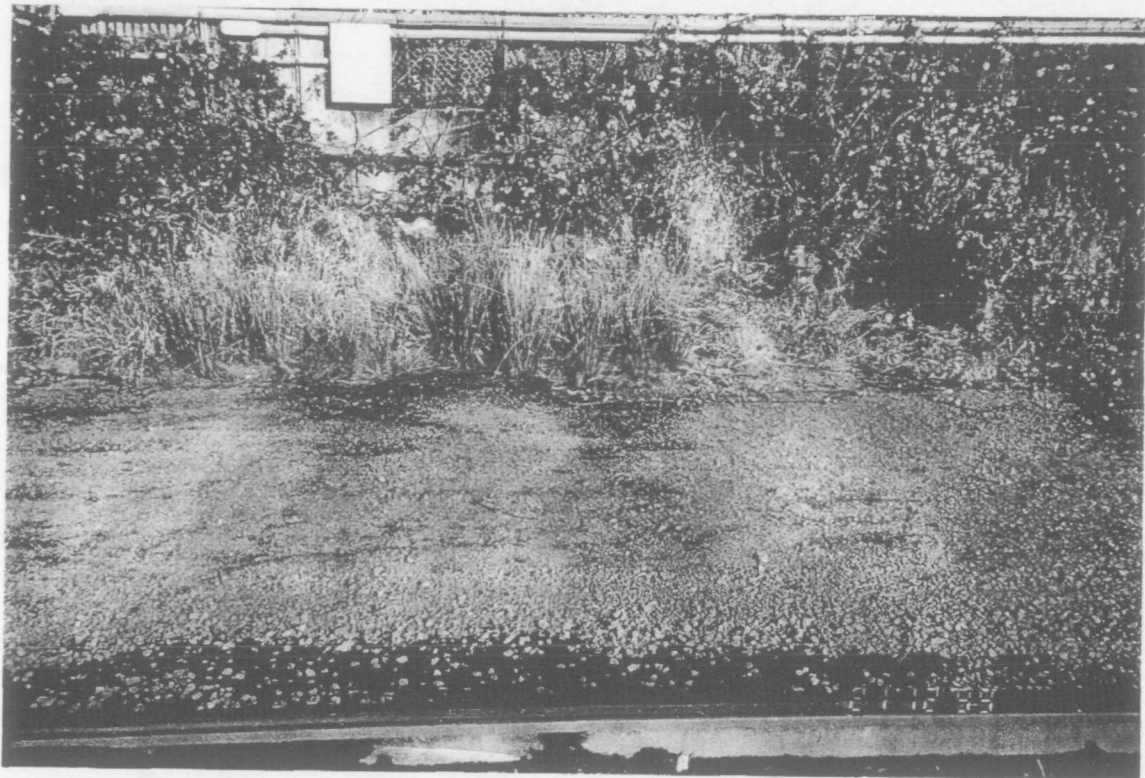
Photo No. 14

Looking north at drain line outlet from west end of Columbia Forge yard.

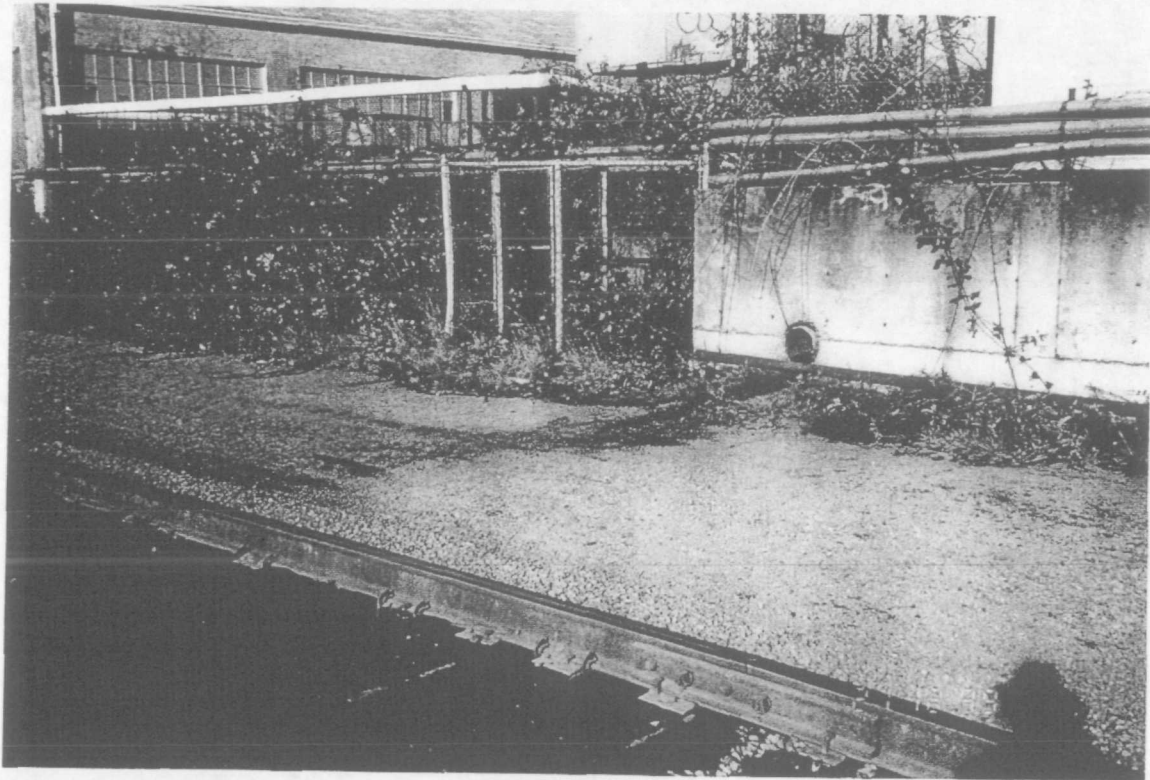
Photo No: 15

Looking north at drain line outlet from east end of Columbia Forge yard.

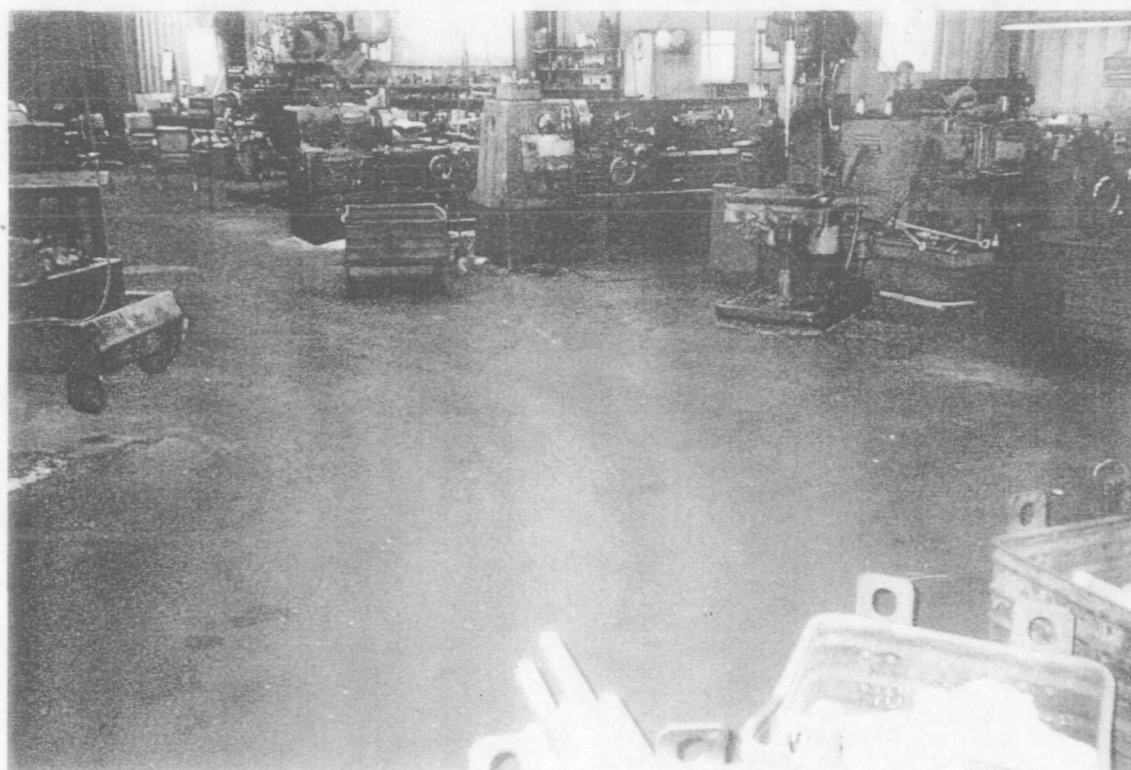
**Photo No: 10**

Machine Shop in north portion of Columbia Forge Building 1.

The northern portion of Building 1 is used for machining and contains several large lathes. This area has a sound concrete floor with no floor drains. Water-based cutting oils were observed in this area and the CSC representatives noted that the facility had been using water-based oil since the late 1970s. Prior to that time, petroleum-based cutting oils were used. No evidence of releases was observed in the machining room.
